STRUCTURAL INSPECTION REPORT

Subject : **STRUCTURAL EVALUATION AND CONDITION OF SCHOOL BUILDING SITE (1 STOREY, 2 CLASSROOM BLSB)**

School : **ANTERO U. ROA CS, Stimson Abordo, Ozamiz City**

Date of Inspection : **April 8, 2025**

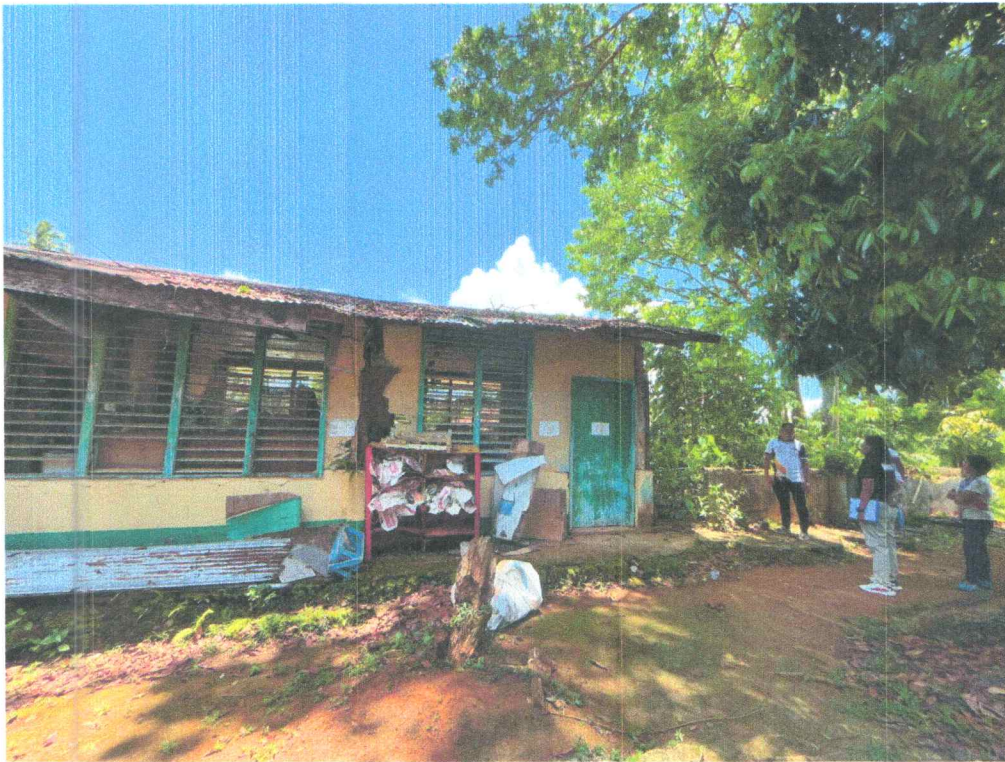
Image 1 (above): Dilapidated columns, roofing sheets, door and windows and other wooden materials.
Image 2 (below): The other classroom's main structure was already demolished and replaced by vegetation growing in the area.

The school building has been dilapidated and unattended for years thus resulting in the materials to deteriorate caused by wood decay, rust, termite infestation, moist, vegetations among others. The exposed foundation of the building was caused by scouring of soil embankment due to erosion during heavy rains thus may result in toppling or collapse of walls and columns. Therefore, it is hereby recommended to demolish the school building to avoid untoward incidents.

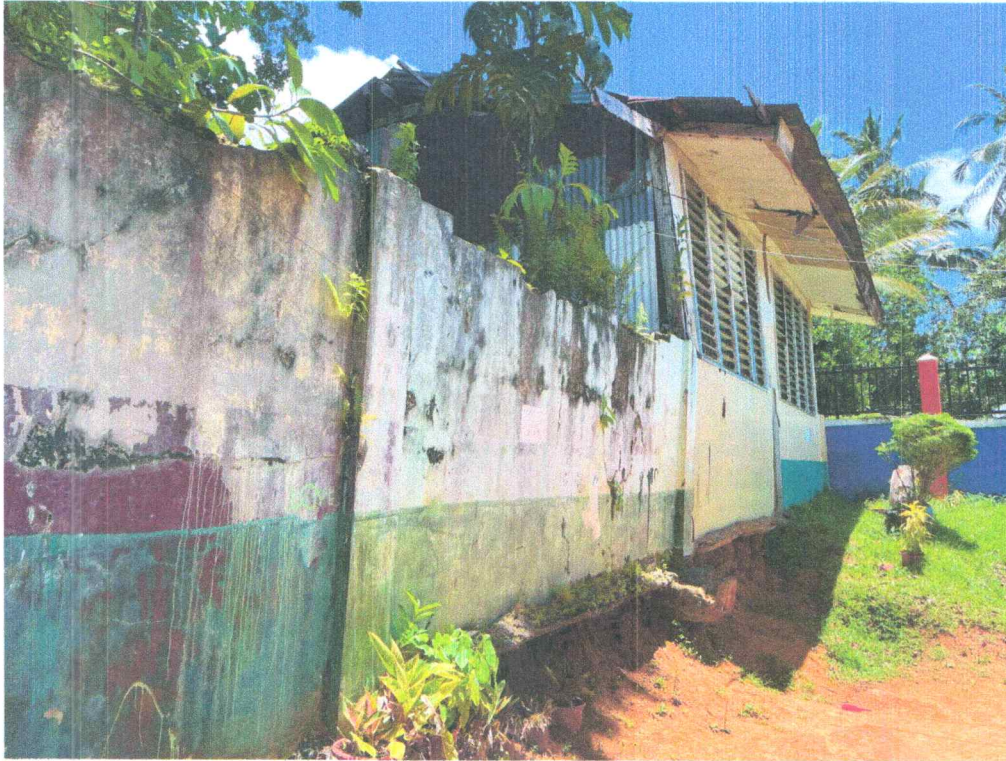
*Image 3 (above): Scoured footing base due to soil erosion, buckling of wooden column due to settlement.
Image 4 (below): The end wall leaned outward due to water pressure and unsupported wall to the column.*

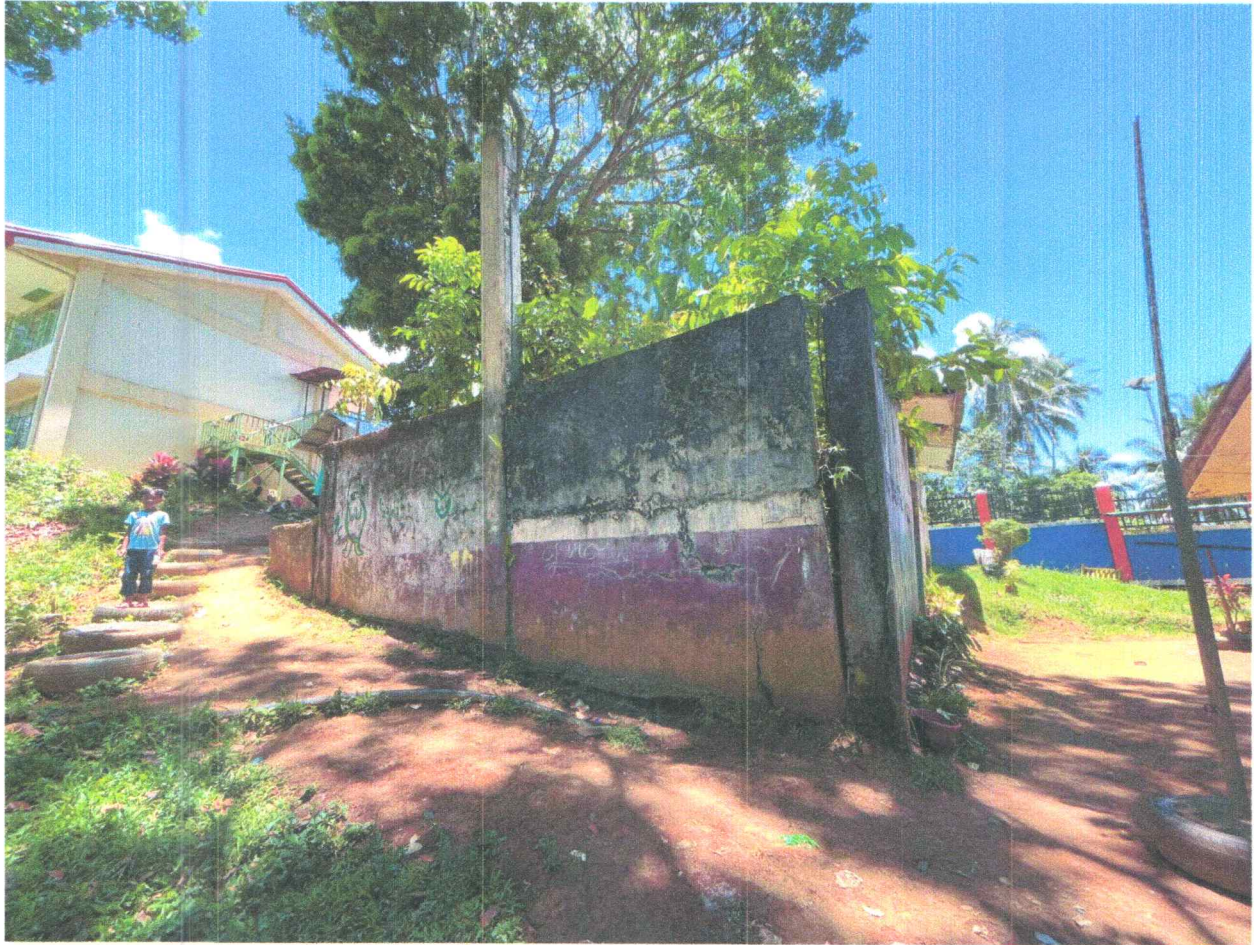
Image 5 (above): The adjacent area of the building is used as the main path walk of students to the main gate thus poses risk of the collapsing wall.
