**PRIORITIZATION OF ELECTRICAL REWIRING IN SCHOOL BUILDINGS**

## ELECTRICAL INSPECTION REPORT

Region/ Division : Division of Ozamiz  
School Name : Marcelino C. Rejis Integrated School  
Location : Kinuman Norte, Ozamiz City

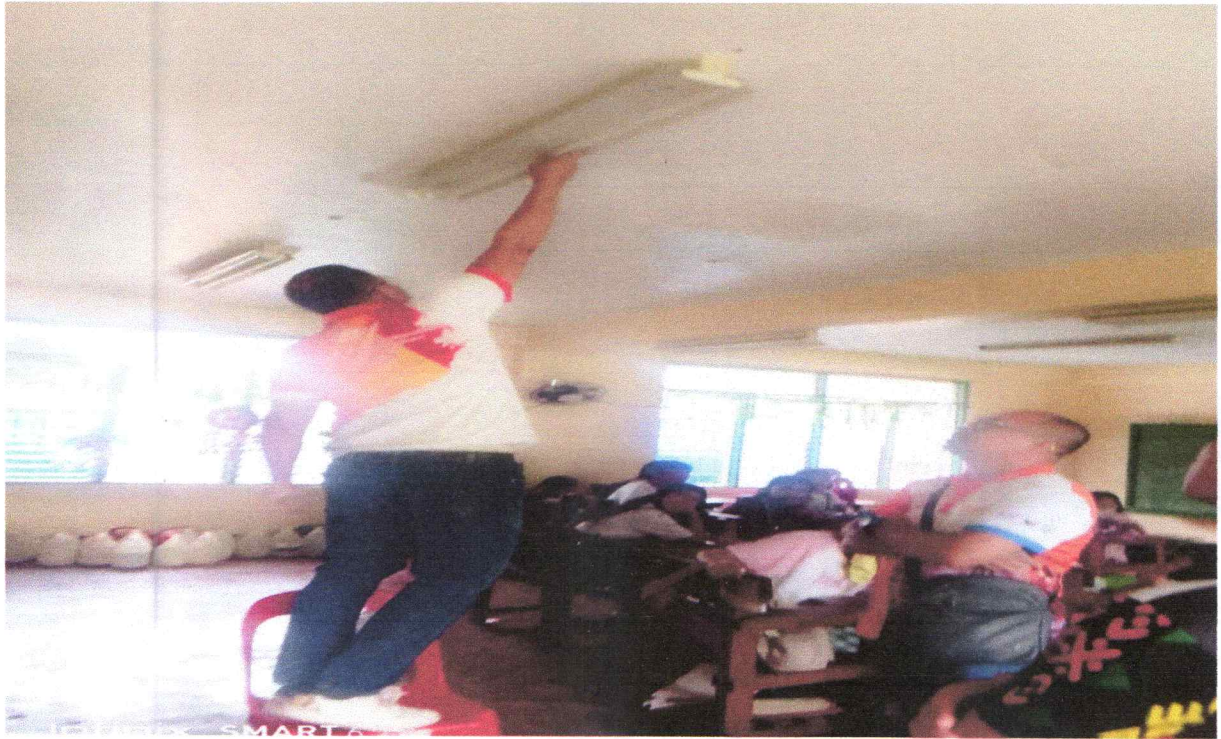
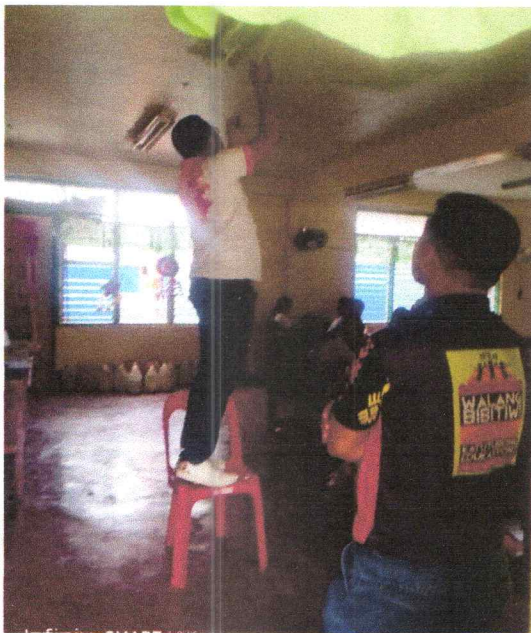
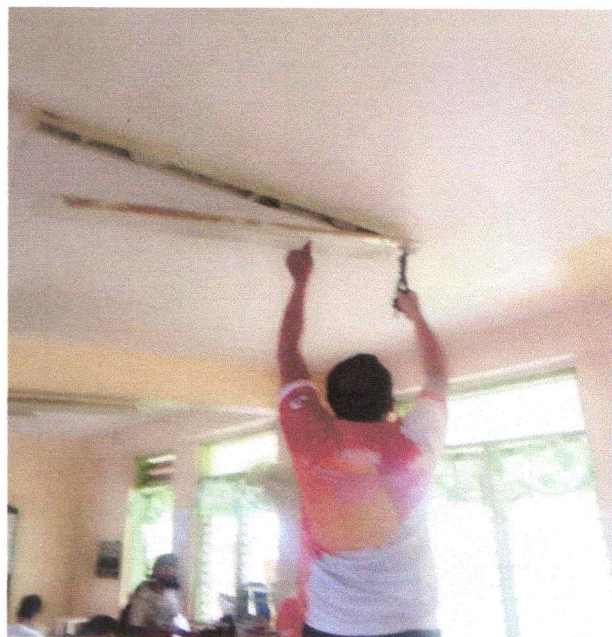
ONSITE INSPECTION:

FINDINGS	RECOMMENDATION
BUILDING 1: BALLAST LIGHTING FIXTURE ARE REPLACED WITH LED FLOURESCENT LAMPS. THAT CAN OVERLOAD THE TRANSFORMER BALLAST AND CAN BE PRONE TO THE ELECTRICAL SYSTEM FAILURE.	REPLACE THE FLOURESCENT LAMP WITH SAME FLOURESCENT (BALLAST TYPE). OR IF USING LED FLOURESCENT, REPLACE THE LED-TYPE FIXTURE.
BUILDING 2, ONE ROOM, WITH A CIRCUIT THE LINE AND COMMON WIRES OF THE LIGHTING ARE ALREADY CONNECTED WITHOUT THE SWITCH! CONTROL AND UPON INSPECTION DURING TROUBLESHOOTING, WE DISCOVERED THAT BUILDING LIGHTING WIRING SYSTEM ARE NOT SPLICE AND CIRCUITED CORRECTLY, THAT MAY CAUSE ELECTRICAL FAULT IN ELECTRICAL SYSTEM. IN THE BUILDING. "WORKMANSHIP OF A LESS EXPERIENCE ELECTRICIAN"	OVERALL REWIRING OF ELECTRICAL WIRING SYSTEM OF THE BUILDING. TO INSURE CORRECT, PROPERLY CIRCUITED, EXACT WIRE SIZE AND STANDARD WIRING SYSTEM OF THE BUILDING.
BUILDING NUMBER 3: 3 OUT OF 6 CLASSROOMS WITH LIGHTING ARE NOT FUNCTIONING; THE LIGHTS ARE FLUCTUATING OR DIMMED, AND MOST OF THE OUTLETS DO NOT HAVE ELECTRICITY. DURING THE INSPECTION AND THRUBLESHOOTING, WE DISCOVERED THAT THE BUILDING LIGHTING AND CONVENIENCE OUTLET WIRING SYSTEMS ARE NO SPLICED AND CIRCUITED PROPERLY, WHICH MAY CAUSE ELECTRICAL FAILURES IN THE ELECTRICAL SYSTEM OF THE BUILDING. "WORKMANSHIP OF A LESS EXPERIENCE ELECTRICIAN"	OVERALL REWIRING OF ELECTRICAL WIRING SYSTEM OF THE BUILDING. TO INSURE CORRECT, PROPERLY CIRCUIT, EXACT WIRE SIZE AND STANDARD WIRING SYSTEM OF THE BUILDING.

We have turned off the circuit breaker for illumination because the buildings are currently in dangerous condition. As a result, there is no light in the facility to keep the students focused on their studies and listening to the teacher.

Because the electrical system's unsafe and inadequate quality, there is a considerable possibility of an electrical failure causing a fire. I strongly propose that the electrical wiring system be completely rehabilitated to protect the safety of not only the pupils, but also the teachers and the community.
