APPLICATION FOR DEMOLITION PERMIT OF THE DILAPIDATED TWO-CLASSROOM BAGONG LIPUNAN SCHOOL BUILDING

STRUCTURAL INSPECTION REPORT

**Subject : STRUCTURAL EVALUATION AND ASSESSMENT OF
SCHOOL BUILDING (1-STOREY, 2-CLASSROOM BLSB)**

School : BAYBAY CS, Baybay Triunfo, Ozamiz City

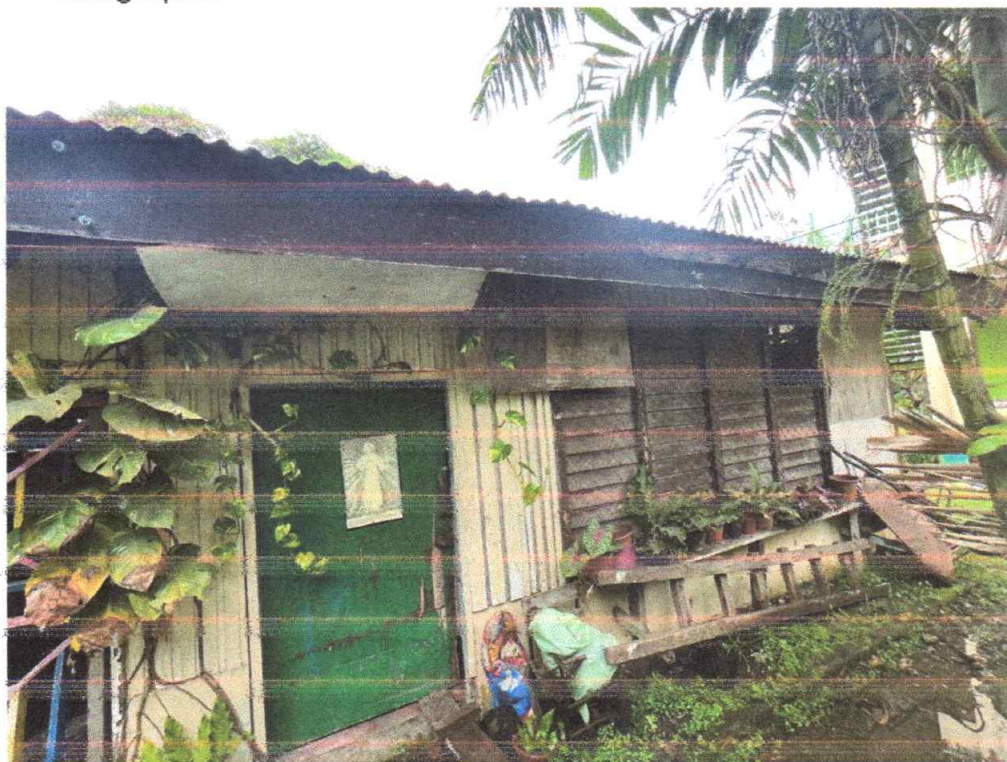
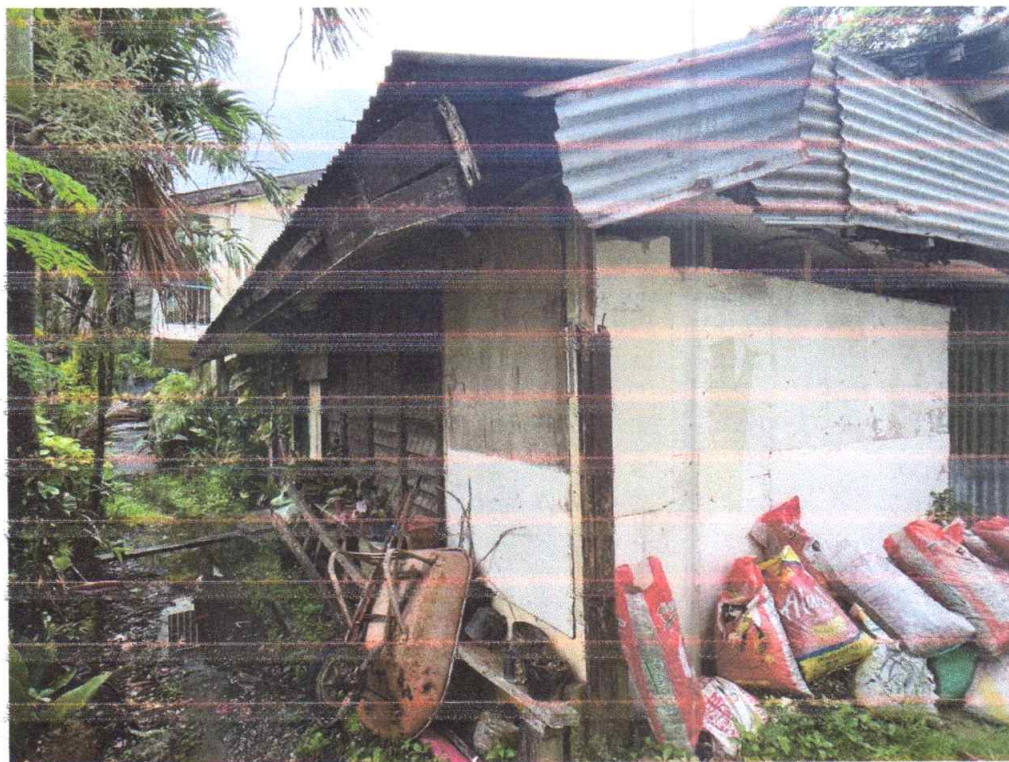
1. The one-storey, two-classroom school building is constructed with a combination of reinforced concrete and timber structural elements. The structure is in an advanced state of deterioration and is considered dilapidated.
2. The timber beams and columns exhibit significant termite infestation and progressive material degradation, primarily attributed to sustained exposure to moisture resulting from roof leakage and frequent flooding.
3. The wall assemblies, composed of timber paneling, are extensively compromised due to severe termite activity, leading to a loss of structural integrity and serviceability.

Image 1 & 2 (above): Dilapidated columns, roofing sheets, door and windows and other wooden materials. Surface runoff accumulated at the building path walk.

The school building has been dilapidated and unattended for years thus exhibiting progressive material degradation and deterioration primarily attributed to sustained exposure to moisture resulting from roof leakage and frequent flooding. The repair and rehabilitation of the said school building are deemed economically impractical due to the extent of structural deterioration relative to the cost of restoration. In view of the building's compromised structural integrity, demolition is hereby recommended as a preventive measure to eliminate safety risks and avoid any untoward incidents.

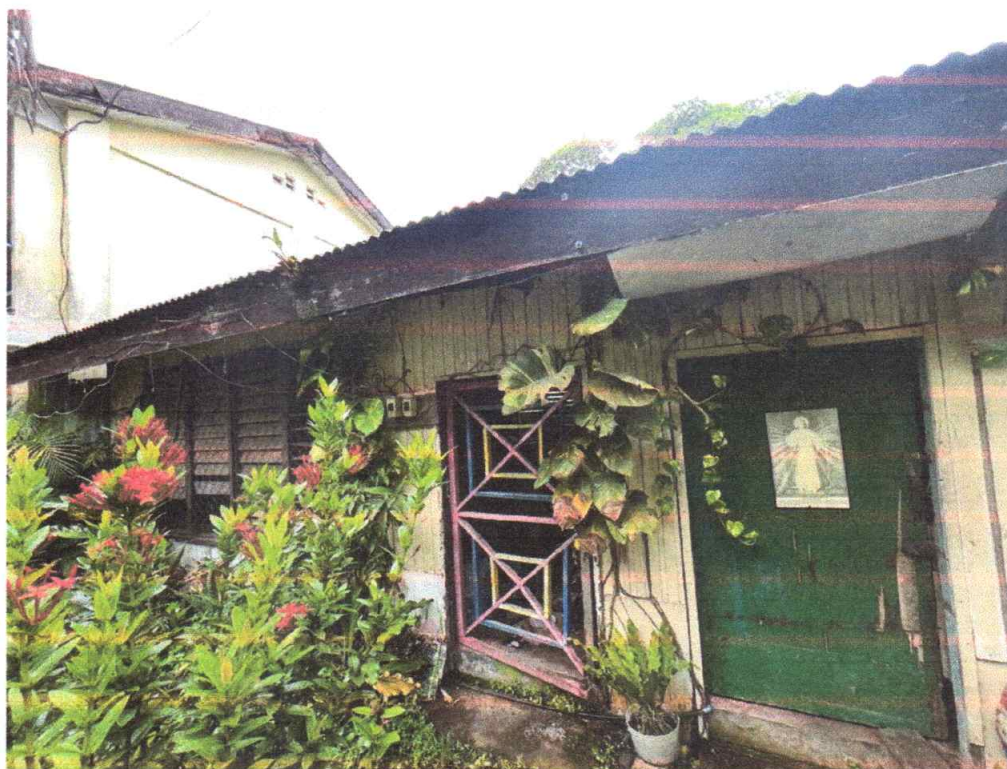
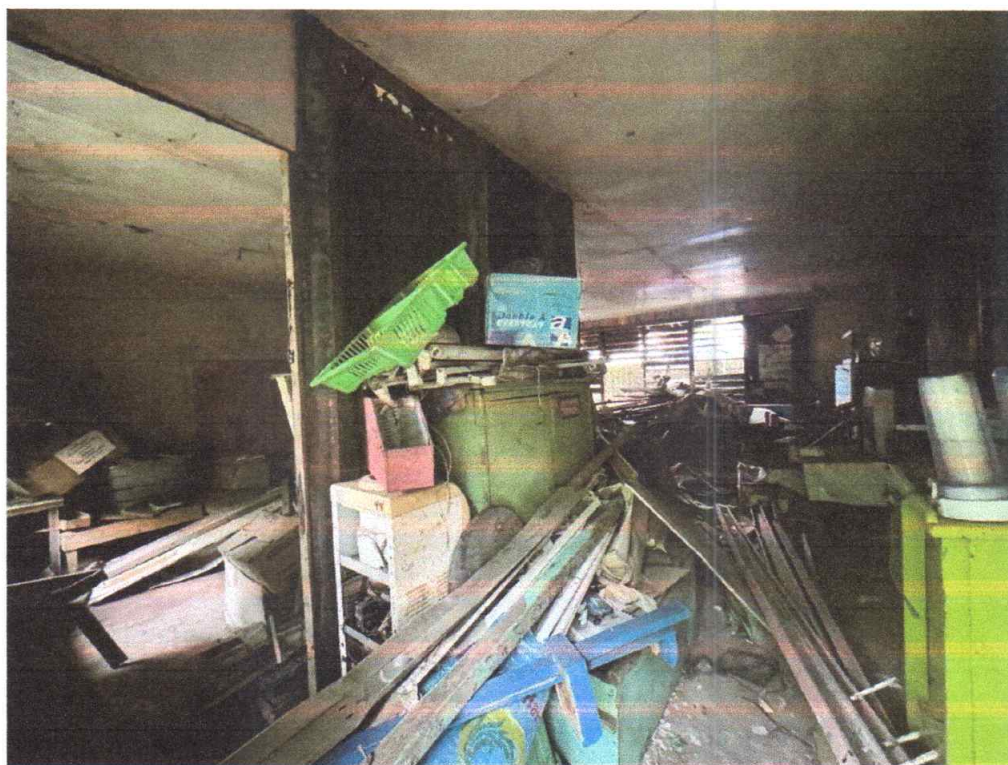
4. Electrical wiring systems are exposed, improperly secured, and show signs of neglect, posing potential fire and electrocution hazards.
5. Due to the construction of an adjacent school building, the surrounding ground level has been elevated, resulting in this structure being situated below the new finished grade. This elevation disparity has created a catch basin effect, where surface runoff accumulates around the building. The absence of an adequate drainage system worsens the situation, causing prolonged water stagnation that may contribute to structural deterioration and compromise the building's foundation integrity.

Image 3 & 4(above): Electrical wirings are exposed and improperly secured. Unattended stocked materials pose potential fire hazard.
